Restoration of printing cylinders on the offset printing equipment KOMORI LITHRONE S40P

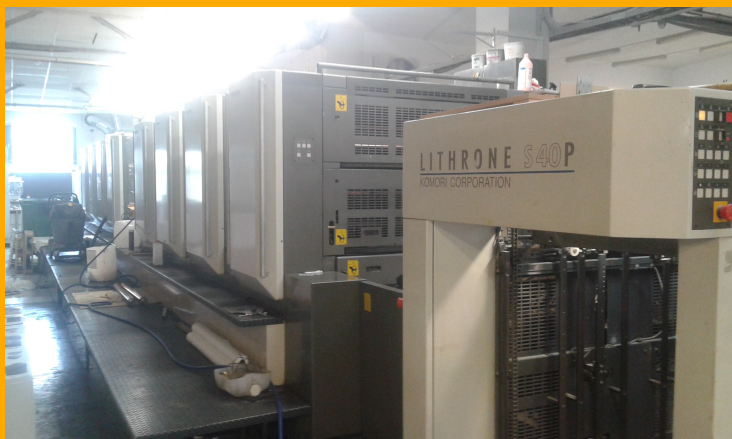
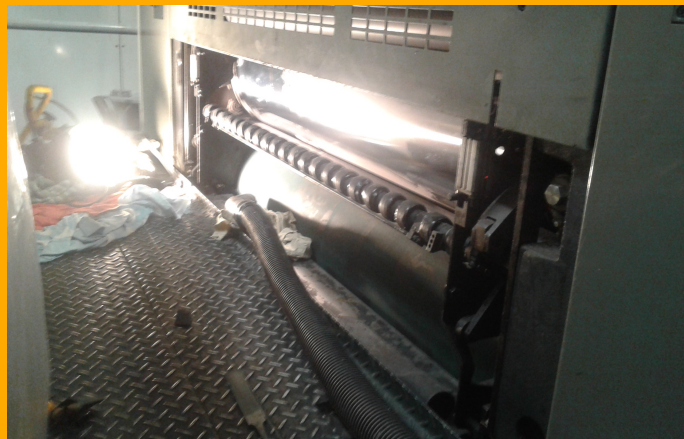
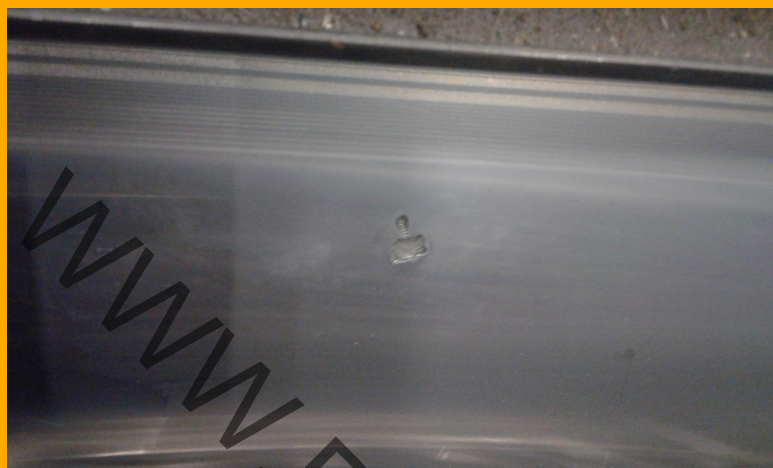
During the offset printing the bolt has fallen to the working cylinder. There was a big and deep dent.

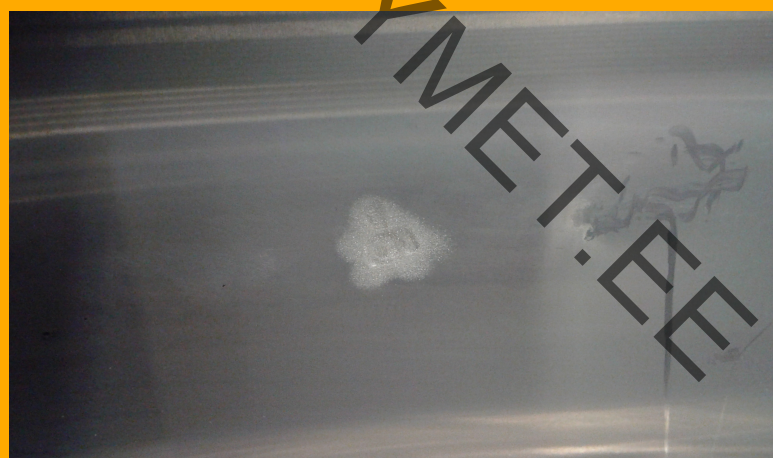
Defect after supersonic cleaning. Depth of defect is 3 mm
